# EMERGENCY MARSH RESTORATION AS PART OF RESPONSE TO THE SWANSON CREEK (MARYLAND) OIL SPILL

**ABSTRACT:** *This oil spill on 7 April 2000 offers a case example where marsh restoration was made as part of the response effort to successfully enhance environmental recovery at a marsh heavily contaminated from a pipeline break (126,000–139,000 gallons of Numbers 2 and 6 fuel oils, >46,000 gallons eventually recovered). Marsh operations guided by U.S. EPA included mechanical trenching, limited low-to-moderate pressure flushing, hand recovery using sorbent pads and working from placed boardwalks, and the aerial application of fertilizer (bio-stimulation). After proving that planting would be successful in pilot plots and in a heavily damaged portion of the marsh, almost all of ‘ground zero’ (W01A) was hand-planted between 21 June and 31 July 2000 with 24,048 plugs of *Spartina alterniflora* and 1,728 plugs of *S. patens* (saltmeadow cordgrass). Both species were locally grown, nursery stock from native seed. Plants were placed in a 3” (8 cm) diameter hole containing 10 grams of slow release fertilizer and back-filled with washed masonry sand. Field surveys indicate recovery of 70-80% af

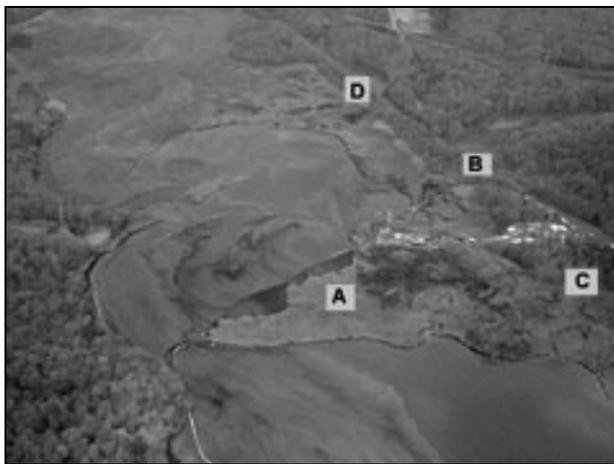
Figure 2. Oiling condition on 15 April 2000, and marsh designations W01A to W01D.

In total, the loss encompassed 126,000 to 139,000 gallons of mostly Number (No.) 2 fuel oil, which was being used to back-flush the pipeline system at the time of the break, mixed with a lesser amount of No. 6 fuel oil that remained in the pipe after transport to the facility and that was mixed into the No. 2 oil via previous back-flush operations. Booms were rapidly deployed in Swanson Creek adjacent to the break and recovery was initiated. Unfortunately, severe winds occurred on the following night (8 April) where upon oil then got past the booms and into the Patuxent River, eventually spreading 17 miles (27 km) downstream and oiling approximately 40 miles (64 km) of shoreline. Of all areas, the marshes in Swanson Creek received the brunt of impacts, especially the marsh designated as W01A, located immediately adjacent to the leak. A location map and an oblique aerial photograph of the Swanson Creek marshes are presented in Figures 1 and 2.

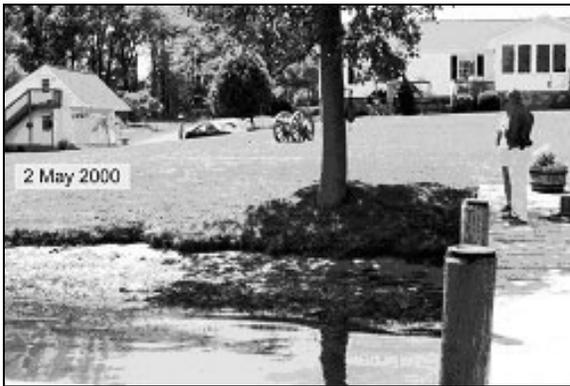
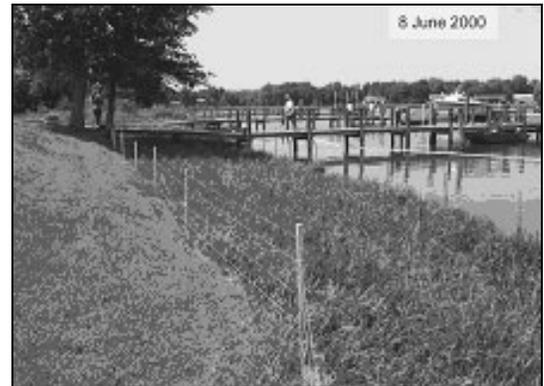
Figure 3. Successfully replanted (*Spartina alterniflora*) coastal strip damaged by cleanup activities. Left - as planting was initiated on 2 May 2000. Right – 5 weeks later on 8 June 2000.

**Phase 1: Replanting fringe vegetation.** Repairs to property damaged by cleanup operations, particularly related to yard repair, were initiated in late April / early May. As part of this effort, several homeowners wished that the marsh strip damaged along their property (which in several cases was being cut as a lawn) would be repaired. After review by representatives of the Responsible Party, EPA, and the State of Maryland, marsh replanting in all but one damaged area was initiated on 1 May and completed a few days later. (The remaining marsh strip was planted several weeks later when permission of the adjacent homeowner was obtained.) This replanting program showed almost immediate success as plants rapidly grew in each site (Figure 3).

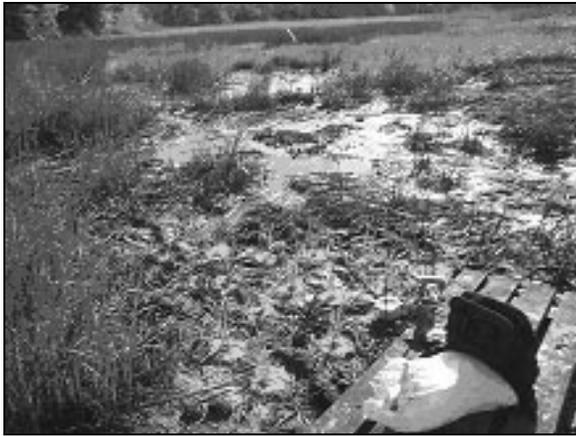
Figure 4. 'Test' plantings in an oiled area of W01A.

In accordance with the Marsh Strategy document, five ‘test’ plots were planted with *Spartina alterniflora* on 13-14 May. Site

locations contained degrees of oil contamination visually varying from light to heavy. The survival and condition of the plants were then followed over time (summarized in Table 1). Figure 4 shows one replanted site in heavily oiled sediments within W01A. The main conclusion drawn from this study was that *S. alterniflora* will survive the stress of planting in oil, and even some re-oiling, as long as they are not repeatedly coated with oil. In addition to the test plantings, a study was conducted to assess natural re-vegetation. Results indicated that the natural recovery of *S. alterniflora* would be limited during the 2000 growing season.

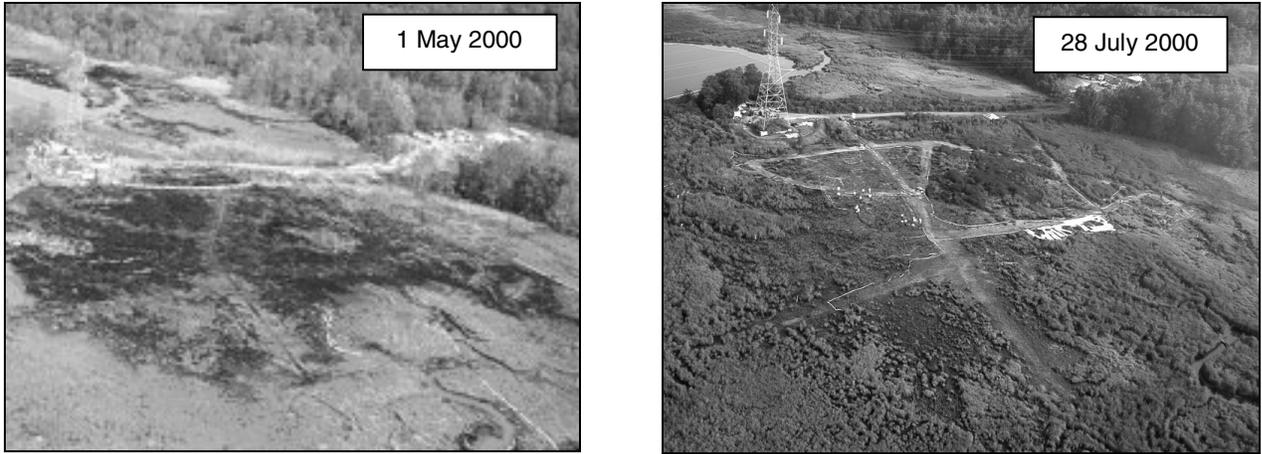
Figure 5. Oblique aerial photographs of Swanson Creek Marsh W01A on a 1 May 2000 and on 28 July 2000 (after completion of planting; some workers and sorbents are still present).

In total, W01A was planted with 24,048 1-2 inch (3-5 cm) plugs of *Spartina alterniflora* and 1,728 2-inch (3 cm) plugs of *S. patens* (saltmeadow cordgrass). Both species were locally grown, nursery stock from native seed acquired from Water's Edge Nursery, Co. of Easton, Maryland. The number of plants installed per week is summarized in Table 2. Plants were placed in a 3 inch (8 cm) diameter hole containing 10 grams of OsmoCote® and back-filled with washed masonry sand. The OsmoCote® was an 18-6-12 coated fertilizer designed to provide 16% slow-release nitrogen (N), 5% slow-release phosphate (P<sub>2</sub>O<sub>5</sub>), and 11% slow-release soluble potash (K<sub>2</sub>O) over a 6-9 month period, depending on temperature. Figure 5 shows aerial photographs before and shortly after replanting / trench infilling.

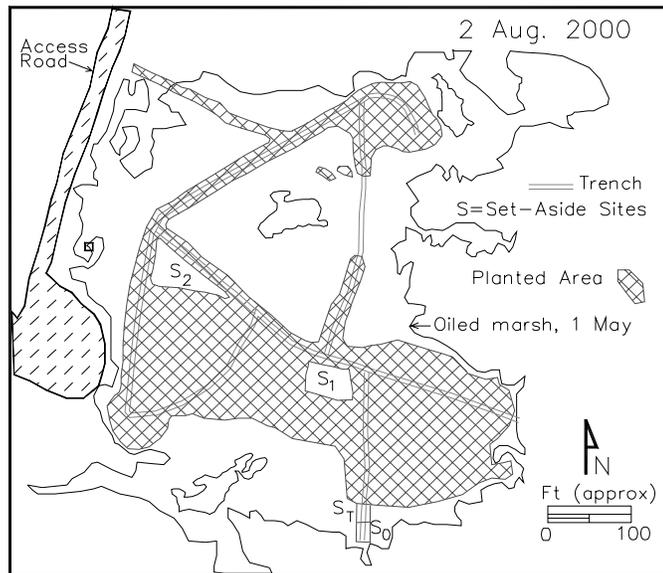
Figure 6. Location of planted areas and set-asides in Marsh W01A. S<sub>1</sub> and S<sub>2</sub> were heavily oiled/unplanted. S<sub>T</sub> = filled trench/unplanted, S<sub>0</sub> = unfilled / unplanted trench.

The location of planted and set-aside areas is indicated in Figure 6. The agencies required that unplanted set-aside areas include a 20 ft (6 m) section of trench (S<sub>T</sub>), a 34x34 ft (11x11 m) square of non-trench (S<sub>1</sub>), and a location near the pipeline break (S<sub>2</sub>). A 20 ft (6 m) section of trench was also left unfilled for monitoring purposes (S<sub>0</sub>).

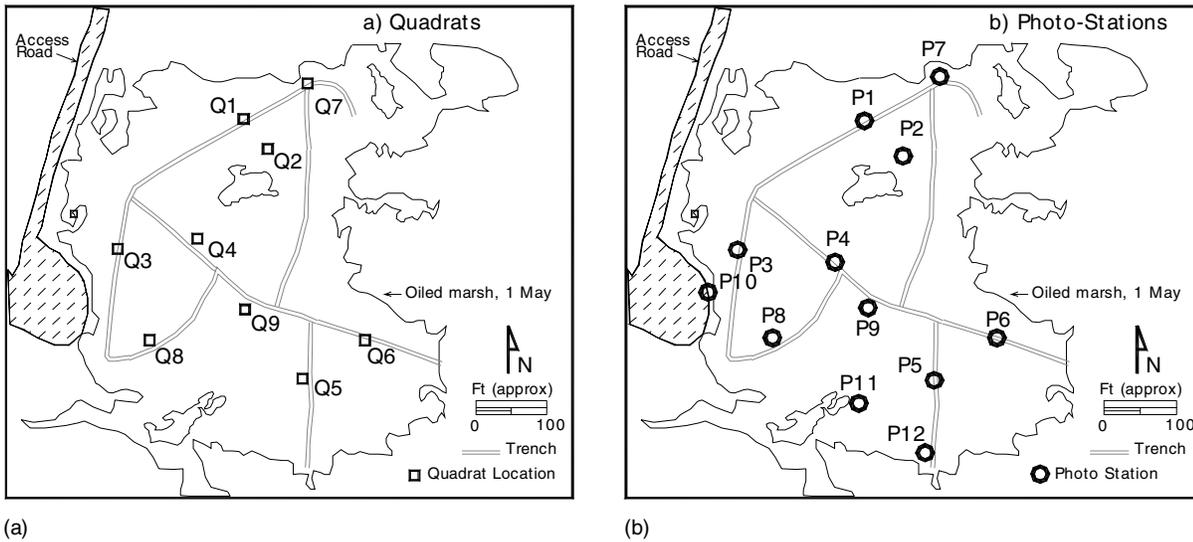
Figure 7. Locations of a) Quadrats and b) Photo stations in Marsh W01A.

On 3 and 4 August 2000, nine 5 ft x 5 ft (1.7 x 1.7 m) quadrats (Q1-Q9) were established to monitor the progress of the repair plantings. Quadrats were located (Figure 7a) throughout the site in all zones except an interior central zone, which was mostly unoiled and showed good growth by July. Quadrats Q1, Q3, Q4, Q5, and Q6 are in previous trench areas, and Quadrats Q2, Q7, Q8, and Q9 are in non-trench areas. Q8

contains *Spartina patens* and all other quadrats contain *S. alterniflora*. Q2 was in an unplanted area. Each quadrat was marked with a painted blue and white striped PVC pole at its top-center and PVC poles at two of its corners. Photo stations were also located throughout the marsh (Figure 7b). Data collected on 3 and 4 August 2000 found that all quadrats had less than 10% plant coverage.

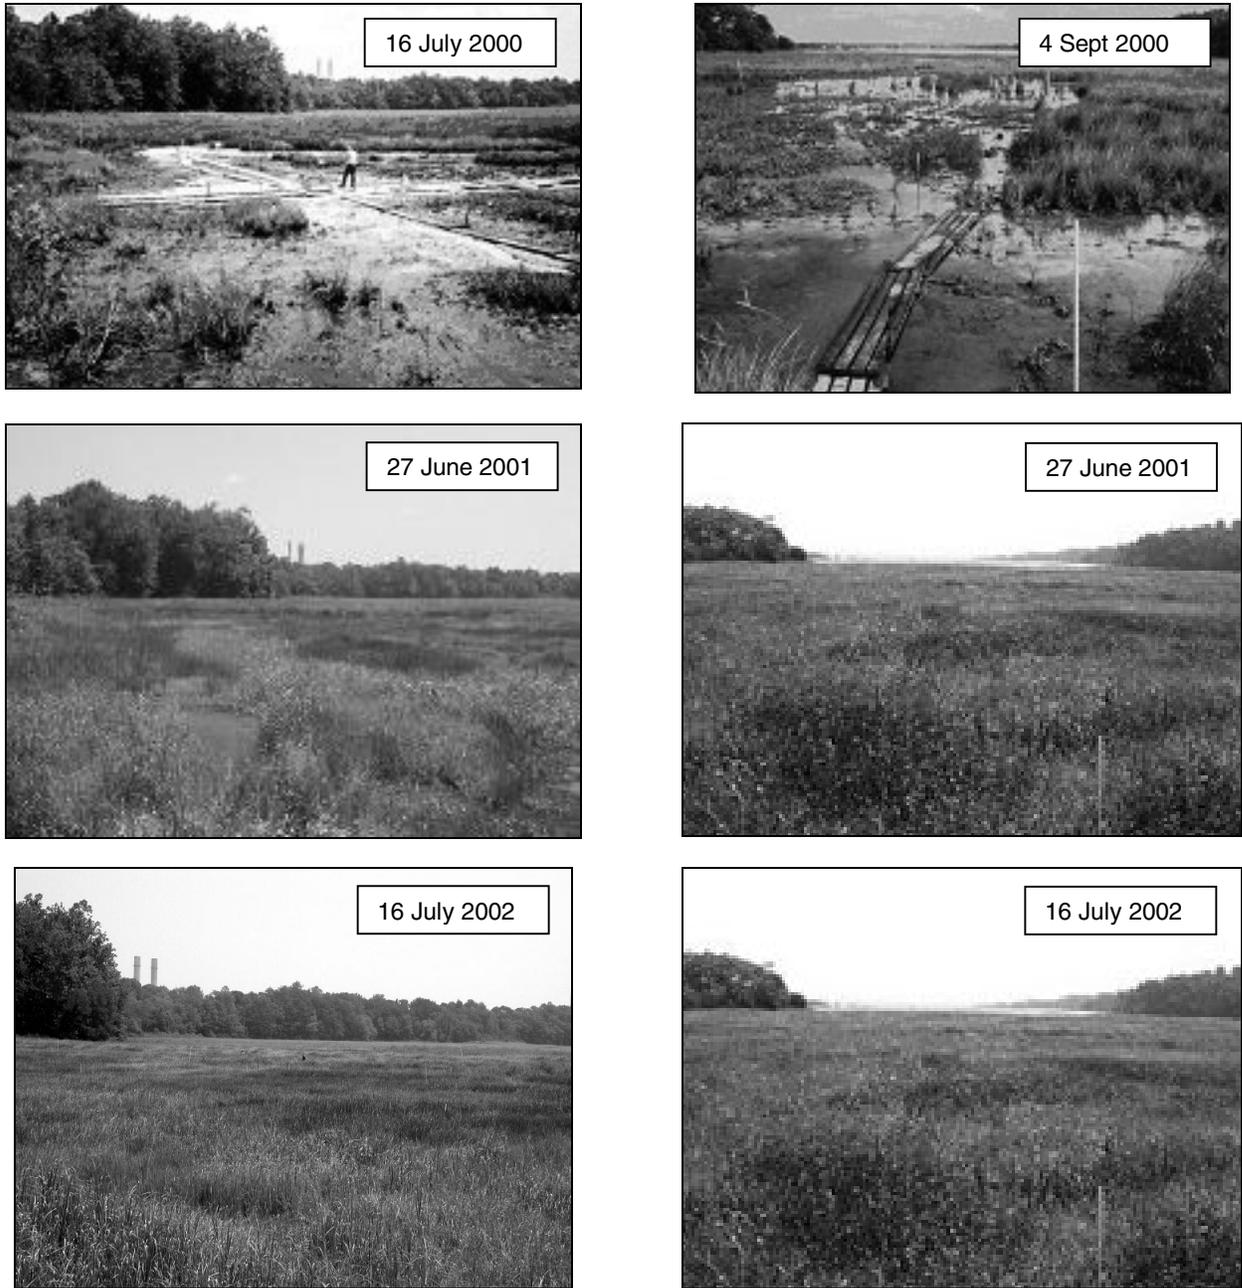
Figure 8. W01A marsh, during year of cleanup / replanting and 1 and 2 years after (from photo station P10).

A followup visit to the marsh on 27 June 2001 took pictures of the site, but did not re-occupy the quadrats. From this visit, it was estimated that plant recovery was approximately 70 to 80%. Overview photos of W01A from 2000, 2001 and 2002 are shown in Figure 8. On 16 July 2002, the site was revisited and all quadrats were resurveyed. Data indicate that plants covered 90% of the area, at or near full recovery (Table 3). Figure 9 presents photographs from three quadrats after initial planting in 2000 and then two years later. A series of additional random quadrats was taken across the marsh as well. Data, presented in Table 4,

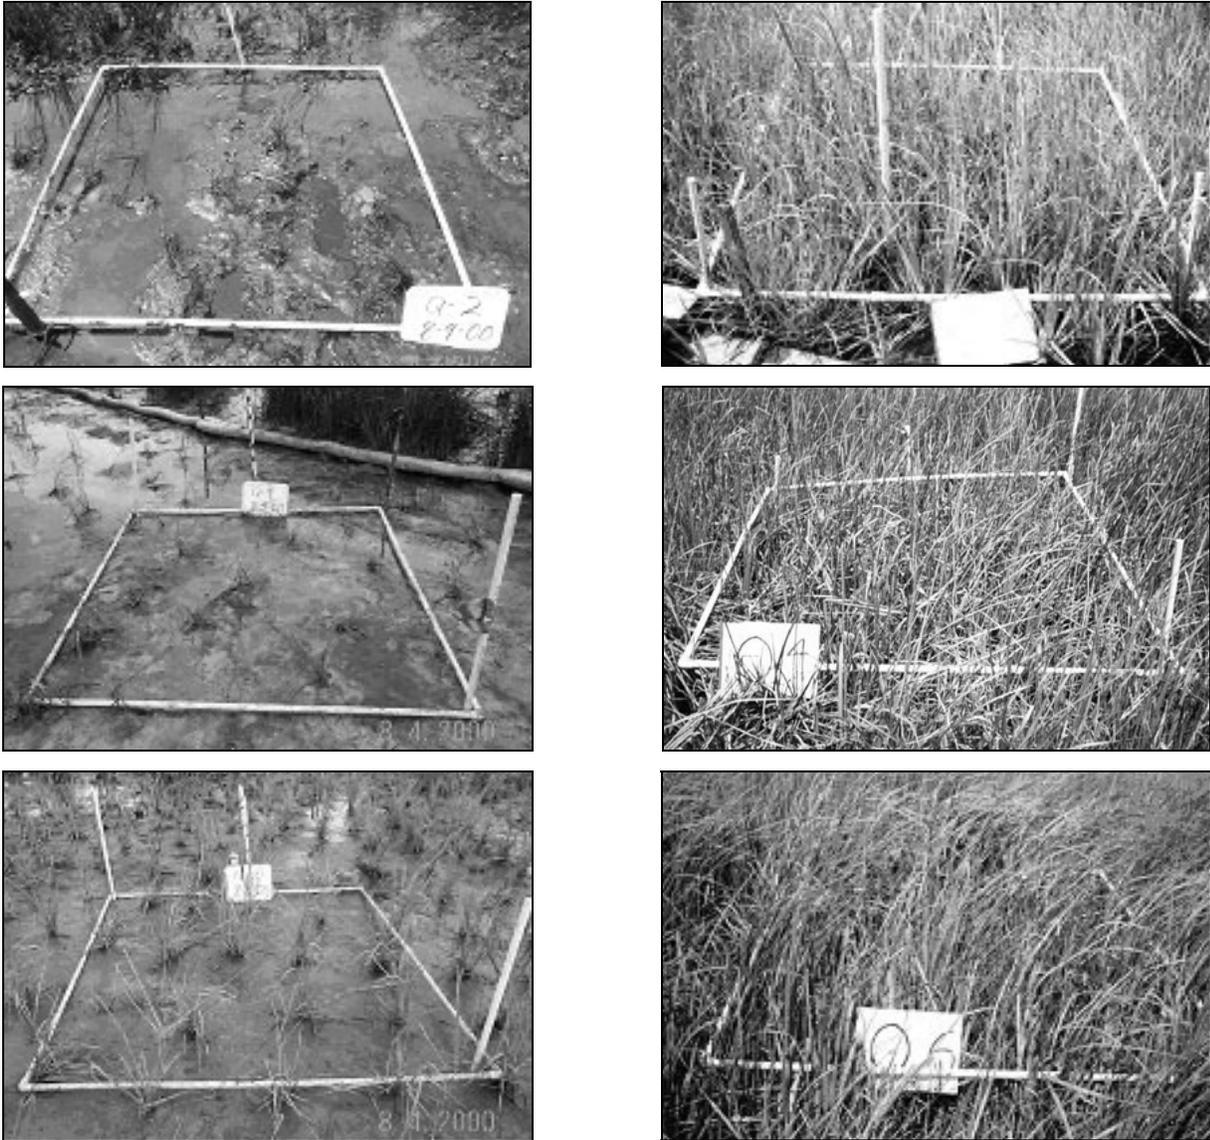
Figure 9. Quadrats 2 (top), 4 (middle) and 6 (bottom). Left side photos are from 4 August 2000. Photos from 16 July 2002 are on the right side.

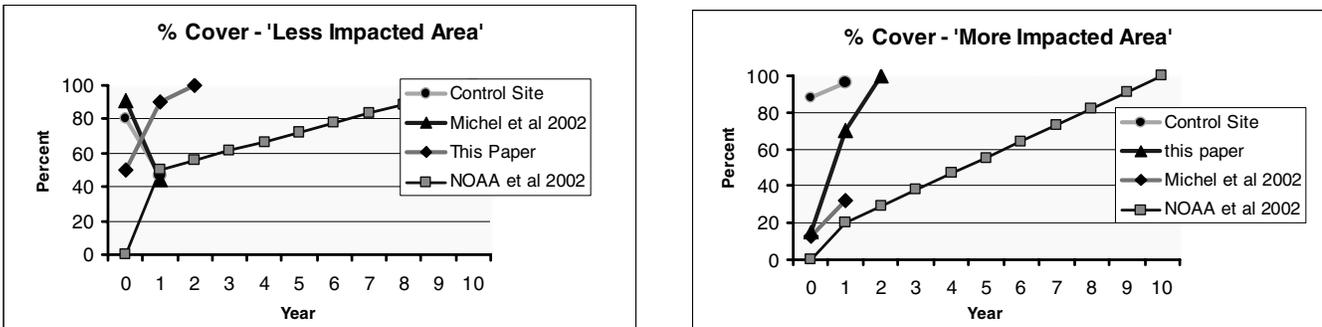
Figure 10. Comparison of recovery data / estimations for 'less' and 'more' impacted areas in W01A marsh (as designated in NOAA et al., 2002)). Control reference is actual site data (average of 3 stations) reported in Michel et al. (2002); this paper refers to data presented herein, Michel et al. (2002) refers to reported field values (average of 3 stations); NOAA et al. (2002) illustrates their recovery curves used to determine marsh acre-year losses and required compensation for damages.

divide the W01A marsh into two categories. For their ‘less impacted’ category they base damages on a 10-year vegetation recovery curve (Figure 10) where  $time_0 = 0\%$ , 1 year = 50%, then 5.56% each year for 9 years. We believe that a much faster recovery time is indicated by the data:  $time_0 = 50\%$ , 1 year = 90%, and 100% after 2 years (also plotted Figure 10). Additionally, Figure 10 shows actual field data from Michel et al. (2002) for the impacted and reference site areas. Note that actual field data show essentially equal values between the ‘less impacted’ oiled area and its reference site.

For the ‘more impacted’ category, the vegetation recovery curve used by NOAA et al. (2002) is also for 10 years, but only 20% recovery after the first year, with then 9 more years to recover fully ( $time_0 = 0\%$ ,  $time_1 = 20\%$ , then 8.9% for 9 years). The data provided in this report indicate  $time_0 = 10\%$  (before planting), 75% after 1 year, and 100% after 2 years (see Figure 10 bottom graph). Field data from Michel et al. (2002) are higher than the NOAA et al. (2002) curve, but much below values given in this report for the second year.
